Air accident account of Liberator AL523 on July 4<sup>th</sup> 1943 at Gibraltar compiled by C.W.T. Walker  
of 172 Squadron, Coastal Command, R.A.F.

INTRODUCTION

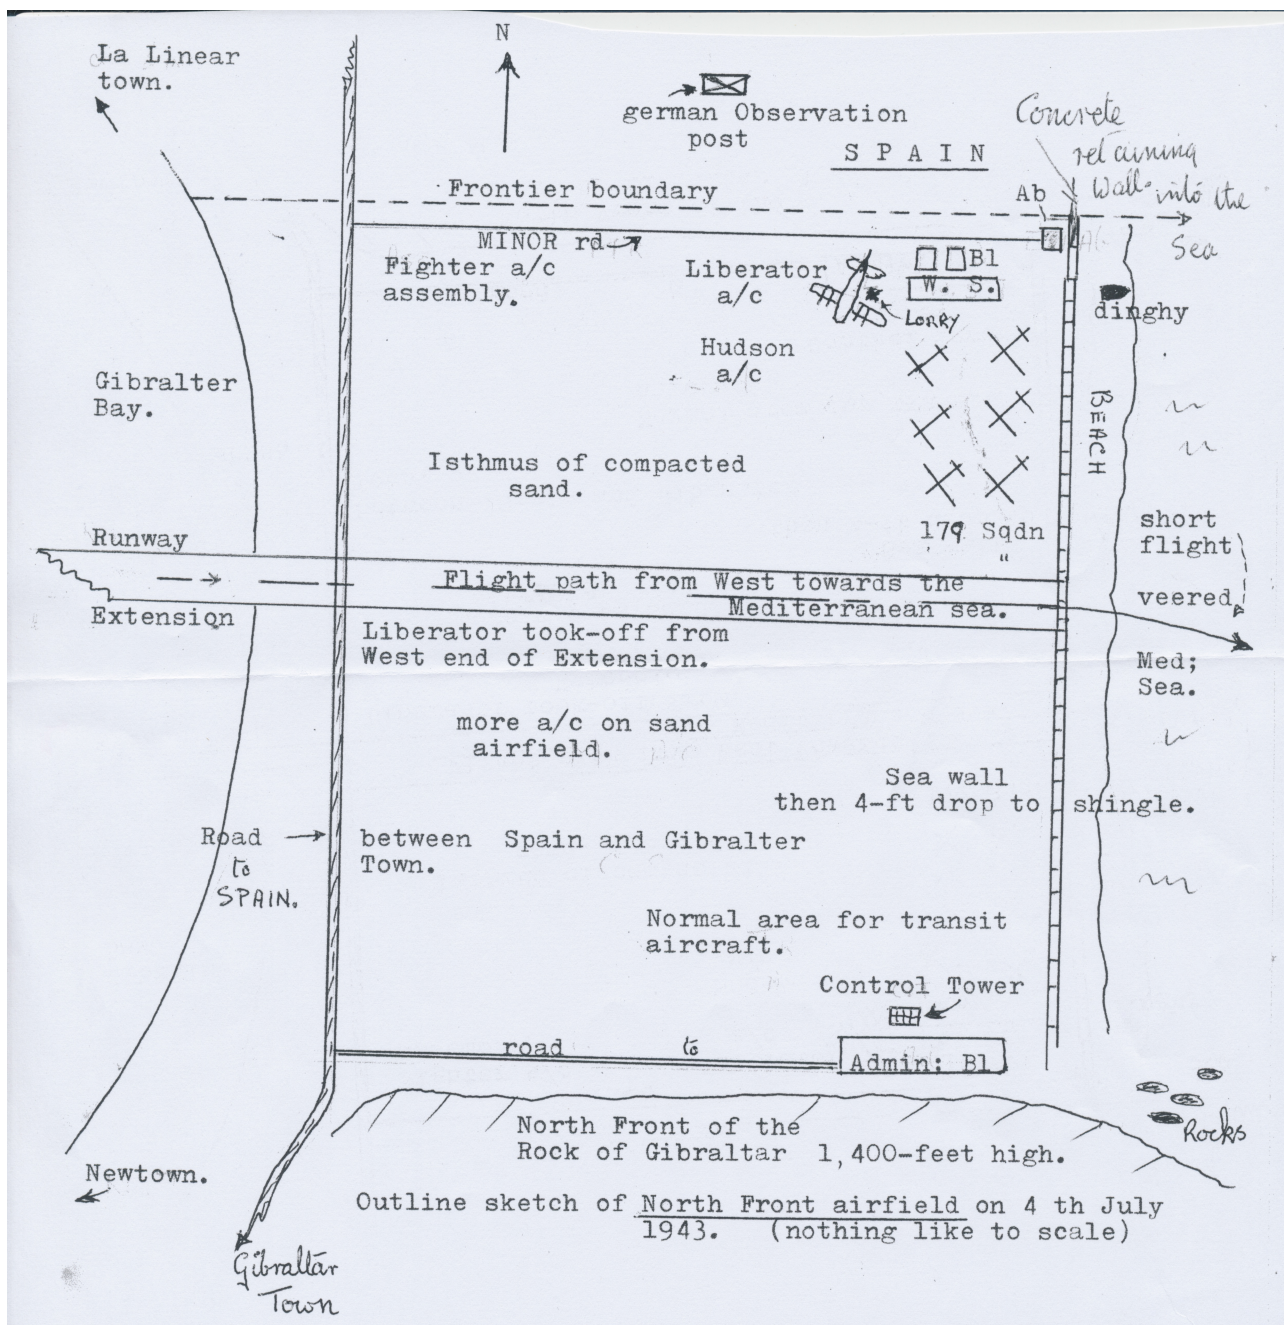
See layout Figure 1, which shows the parked Liberator close to a Perimeter road parallel to a high chain mesh which served as the Frontier to Spain. The service road terminated at the Ablutions Block (Ab on Figure). The Frontier mesh went into the Mediterranean Sea. Next to the Liberator was our Billets of 172 Squadron along with the workshops and parked Wellington Aircraft. At the far side of the Liberator was a squadron of Lockheed Hudsons. The NAAFI was near the Control Tower and the limestone rock-face. A service road ran parallel to the rock-face to the road into Gibraltar Town. The Main road from the town crossed the single runway to the Spanish and British Frontier control gates.

Figure 1. Gibraltar North Front Airfield July 1943.  
My billet labelled BL (just right of parked Liberator).

Dinghy [Clarification of whether the dinghy my father and others upturned on the beach but found no oars for was the official rescue dinghy.] I'm puzzled I do not recall a [rescue] dinghy housing. [I] ran down to the beach and [to] a dinghy. The one shown on my sketch [Fig. 1] was the one seen and that [the rescue attempt] occurred over a short period.

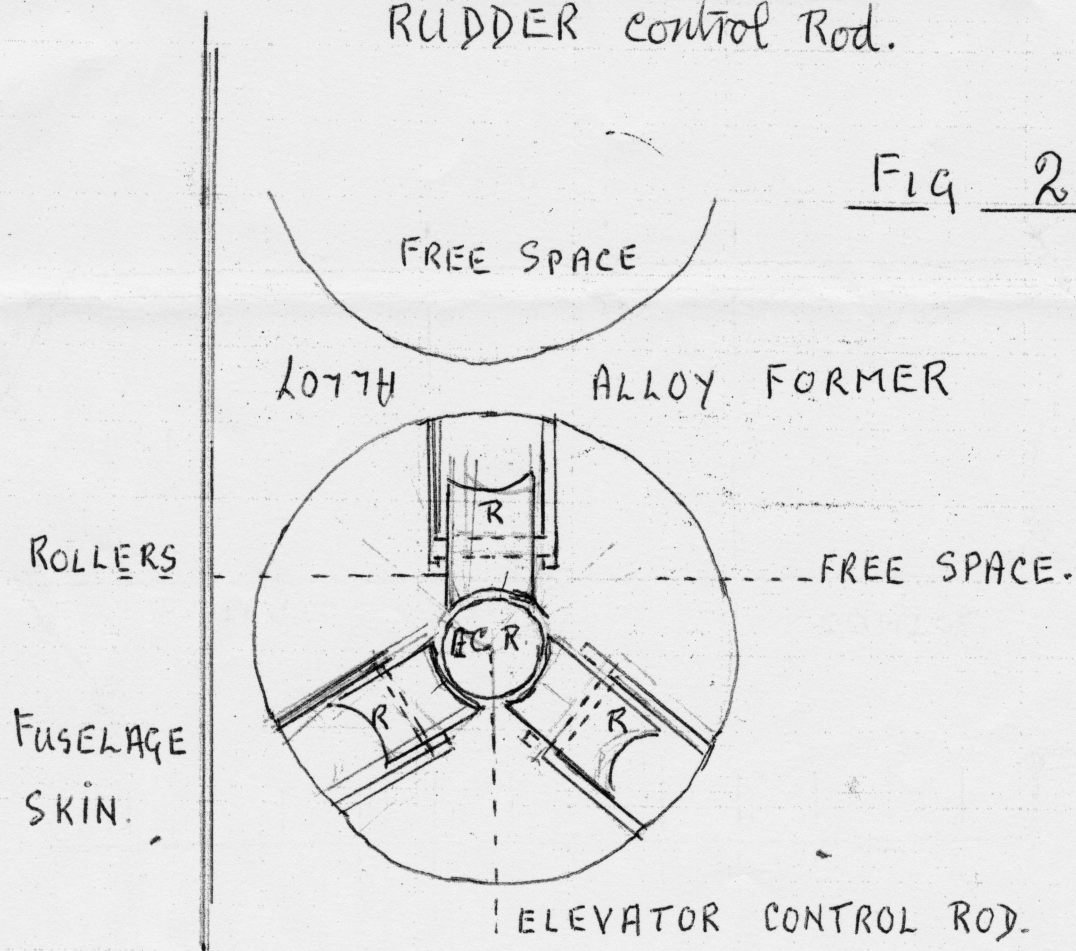
Fig 2.

CONTROL-RODS The rods were about 1-inch in diameter on the starboard side. Long lengths of tubing were coupled together by universal 'knuckle-joints' to allow for fuselage curvature. Two joints were opposite me, each above the other and held in a large hole by 3 rollers to provide a snug fit (see Figure 2). The upper rod I assume was to move the Rudder; the lower rod the Elevators. External to the aircraft the Rudder and Elevators had some form of 'Locking' as in level flight. There were no wire cables. The lower one was roughly 5 +/- 1 foot from the floor. The Rudder knuckle a foot higher.

COMMENT I thought this arrangement to control large flight surfaces as a strong lightweight control system, without backlash.

The jamming of the elevators to lift the tail-unit made the aircraft do a downward loop into the sea. This was possible during the right hand turn (starboard wing down a bit) for some piece of the unsupervised load to slip in between the widened gap between a former and a knuckle joint. When the aircraft hit the sea-bed, passengers and loose cargo would be thrown forward including the obstruction, and would not have any evidence as to what happened.

Next Hole above had the  
RUDDER control Rod.

Figure 2. Detail recalled of Liberator control rods seen.

Page 200 – 201 Q.18 [Postgate's Q&A session continued] Answer[ed] aircraft elevator locked when he tried to level upward flight by pushing joy-stick beyond neutral to a forward position; that's when something moved and a cargo box dropped in between a stiffener and a knuckle-joint. Jammed to cause 15 – 20 degree loop downwards and would be getting steeper if the aircraft had been higher up.
