Salvaging a Wreck

Published in the July 2017 edition of *Micscape* magazine.

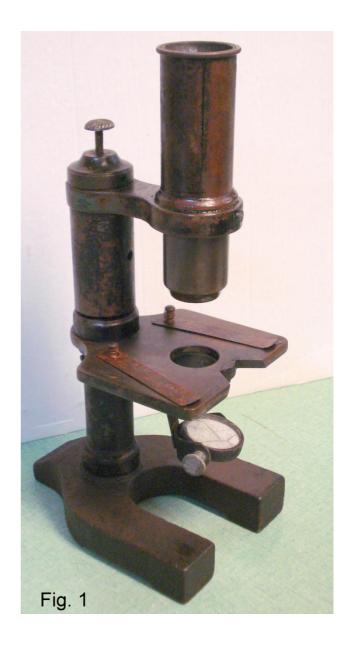
Once again I found on eBay an "old wreck of a microscope" (Fig.1) and managed to purchase it at a reasonable price. From its design I deduce it to be a) of Continental European origin and b) from the late 19th century: It has a cast iron horseshoe base, plain stage, fine focus in the main column, coarse focus by sleeve (no gear whatsoever) and is not of the highest precision. The drawtube was missing as were an objective or an eyepiece when I got it, and the condenser sleeve cum mirror bracket under the stage appears to have been added later. It had no apparent signature in the condition as I got it, but upon polishing the stage I came upon a fragmentary signature Qu......A and a serial number 3094 .(Fig.2). There could have been an "a" after the Qu, but unfortunately some previous owner had cut a section off the stage, for whatever reason, thus obliterating most of the engraving.

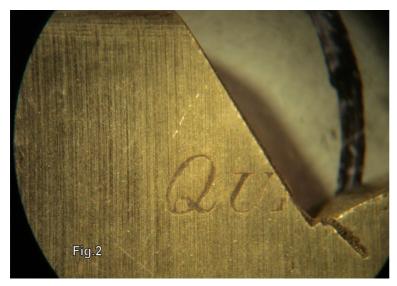
The first step of the reconditioning was to disassemble the entire instrument and clean it. Then I removed the old paint, lacquer and corrosion by carefully sanding or remachining all parts, leaving the deeper dents (Fig. 3) It was then that I noticed that the triangular prismatic bar of the fine adjustment was either

crudely made or had been tampered with subsequently. In any case it fits rather loosely into the outer part. There is a shimming plate, but it lacks the usual screws to press it against the shaft to reduce slack, nor can it be removed to underlay additional shimming because for some weird design it cannot be removed! This really puzzled me: the plate has an oblong recessed slot with a screw or bolt that prevents

it from sliding from the triangular guide. This screw or bolt is inaccessible from the inside nor could I detect any signs on the outside of any "rivetting" or similar device to secure it. I decided to leave things as they were.

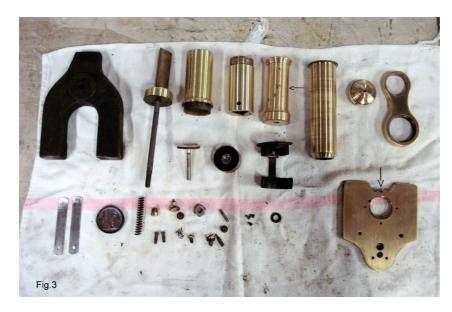
Fig. 4

The fine focus mechanism is also of an unorthodox design and as one major part had been replaced by a rather crude pin, it took me a while to figure out how it worked and what I needed to make to get it going. The action end of the pressure spring inside the

Schematic of focusing mechanism

stationary triangular prism shaft rests on a lifting pin that protrudes from the outer body

through the shimming plate and a slot in the prism shaft. The length of this slot limits the fine focus range. Turning the fine focus down lifts the outer body with the pin compressing the spring. In the illustration the hatched sections are the moving parts. I have not come across a similarly designed fine focus in my experience.

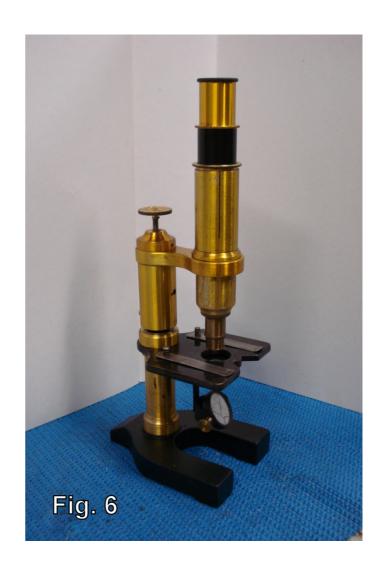
Fig. 5

I had a graduated black drawtube in my stock that fitted the old tube once the felt lining was replaced. This tube had the usual stop screwed in at the lower end which normally prevents it from being pulled totally out. This I had to machine off in order to insert it from above, its knurled outer rim was too large in diameter to fit into the main tube. That draw tube also lacked the upper end sleeve for the eyepiece which I could machine from a suitable piece of brass on hand. I also found in my scrap box an old condenser which I could reshape to fit into the condenser sleeve on the underside of the stage. This may be somewhat anachronistic as microscopes of this type rarely were fitted with a condenser, perhaps a cylinder stop.

Eyepiece sleeve
